Accelerated reliability testing of articulated cable bend restrictor for offshore wind applications

Keywords: accelerated testing, cable protection, offshore renewable energy, submarine power cable, reliability

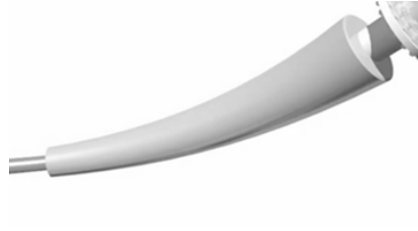
Figure 1: Mechanical cable protection systems

82 Cable protection systems (CPS) are commonly used in the oil and gas and
83 offshore wind industry to prevent damage to an umbilical cable (or riser) from
84 overbending. There are two types of CPS, *bend restrictors* and *bend stiffeners*.
85 Indicative drawings are shown in fig. 1.

86 *Bend restrictors* (fig. 1(a)) usually comprise a number of interlocking ele-
87 ments which are compliant until a specified bend angle/bending radius, greater
88 than the MBR of the cable, is reached. The elements thus protect the cable
89 from overbending. The bend limiter accepts the bending moments, once the
90 design angle / bend radius is reached. They are best suited to protect the cable
91 during installation and operation in static or quasi-static conditions.

92 *Bend stiffeners* (fig. 1(b)) are tapered mouldings that add local stiffness to
93 cable or umbilical to limit the bending stresses and curvature to acceptable
94 levels, avoiding failures due to fatigue and overbending. They are best suited
95 for dynamic applications to control/reduce the in-service bend radius to achieve
96 a specified service life. This design provides local stiffness to the cable, thus
97 limiting bend stresses, fatigue and curvature. The bending stiffener body is
98 commonly made from polyurethane elastomers.

(a) Bend restrictor

(b) Bend stiffener

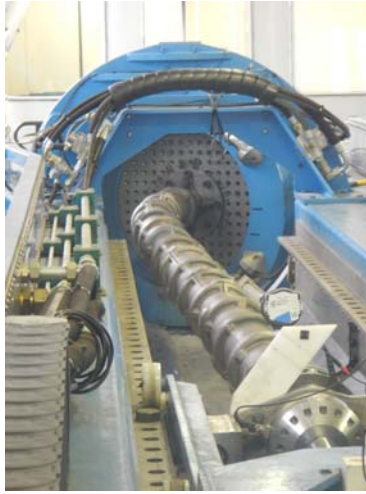
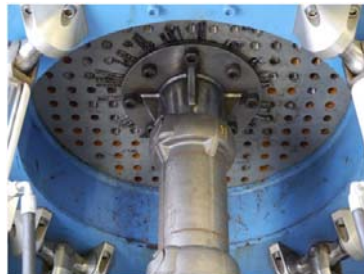
Figure 2: Experimental setup of cable/cable protection system at Dynamic Marine Component test rig, length of specimen is 5.4m

(a) Setup overview

(b) Tailstock

(c) Headstock

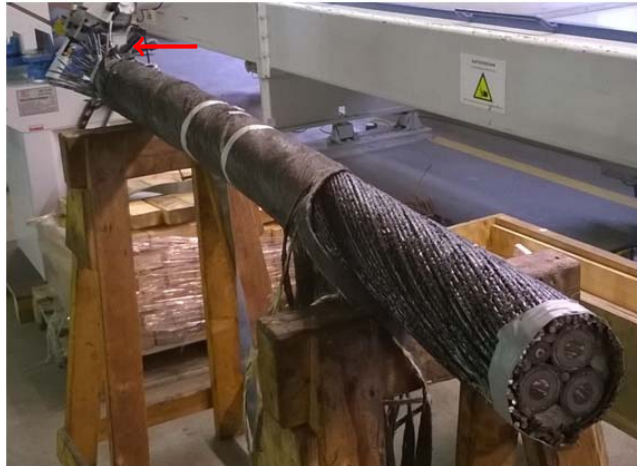
Figure 9: Power cable section before dissection and analysis. The arrow indicates end mounted to test rig headstock.

The cable specimen was returned to NSW after the mechanical loading tests were completed. As loads applied during the test were significantly above the mechanical design limits of the cable, failures were expected. The cable was dissected at NSW's facilities in Germany. The tested cable had a total length of 5.4m. For the dissection, 2m length have been selected from the end that was connected to the DMaC headstock and thus was subjected to the largest cyclic bending stresses. The shortened section before dissection is shown in fig. 9.

498 *Serving, armouring and bedding.* Wear was evident on the cable serving PP
499 yarns. Particularly significant in the section starting from the cable end con-
500 nected to the DMaC headstock during testing, for a length of approximately 1m.
501 Some instances of armour wires crossing were noticed. These were assumed to
502 be the result of cable section cutting, transport and handling. No damage was
503 identified on the armouring steel wires. No damage was noticed on the bedding
504 layer.

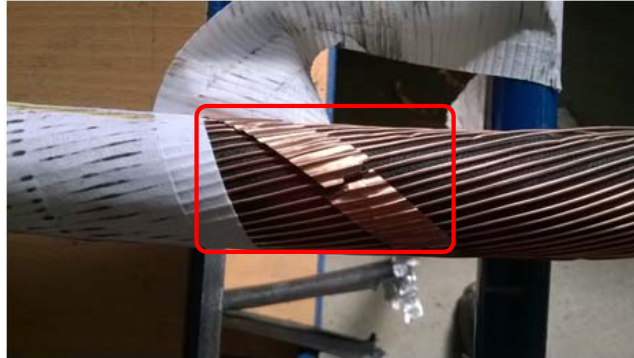
Figure 11: Copper tape damage identification

460 *Bending fatigue.* The repeated, cyclical bending of the cable subjects it to ma-
461 terial fatigue. The repeated bending induces stress in the individual components
462 and in particular the outer layers of copper and aluminum tape are exposed to
463 repeated stresses that are below the material yield stress, but are large enough
464 to induce fatigue damage. For the most severe loading case with 28^{circ} bending
465 angle the Al sheath was exposed to up stresses up to 65% of its yield strength,
466 whilst the copper tape was subject to up to 35% of its yield strength. The
467 physical process of crack initiation and crack growth could not be monitored
468 during the tests, but the microscopic analysis, shown in figure 10, reveals several
469 fatigue cracks in the Al sheath which are up to $50\mu m$ long and are perpendicu-
470 lar to the maximum stress direction. The analysis of the copper tape, depicted

471 in figure 11, shows a fatigue fracture with associated fatigue cracks that have
472 propagated perpendicular to the maximum stress direction. The likelihood of
473 both failure modes is also suggested by the S-N fatigue curves shown in figure 8.
474 The test regime exceeds the nominal fatigue life in both cases. Therefore, the
475 failure likelihood regarding bending fatigue is judged as high.

513 *Metallic screen.* Significant damage was found on both copper tape and screen
514 wires (fig. 11). The copper tape had numerous fractures in the section subjected
515 to bending as shown in fig. 11(a). Figure 11(b) shows multiple fatigue cracks
516 developing from the copper tape edge as indicated by the red arrows.

(a) Fatigue failure

(b) Fatigue cracks

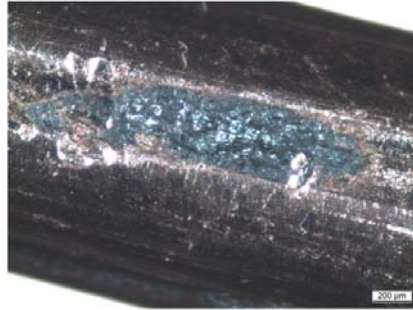
Figure 13: Conductor wire fretting

524 *Conductors.* All conductor copper wires were found in good condition, although
525 some signs of fretting were identified. Figure 13(a) shows signs of fretting occur-

ring at a contact point between copper conductor wires, while fig. 13(b) shows a superficial crack initiation on a conductor wire surface.

(a) Fretting between two conductor wires

(b) Fretting on conductor wire surface
